MAPPING AND MONITORING GROUNDWATER AND IMPLEMENTING THE GROUNDWATER DIRECTIVE IN NORWAY

Pål Gundersen, Anna Seither, Atle Dagestad, Øystein
Jæger – Geological survey of Norway

National level - Norwegian Groundwater monitoring

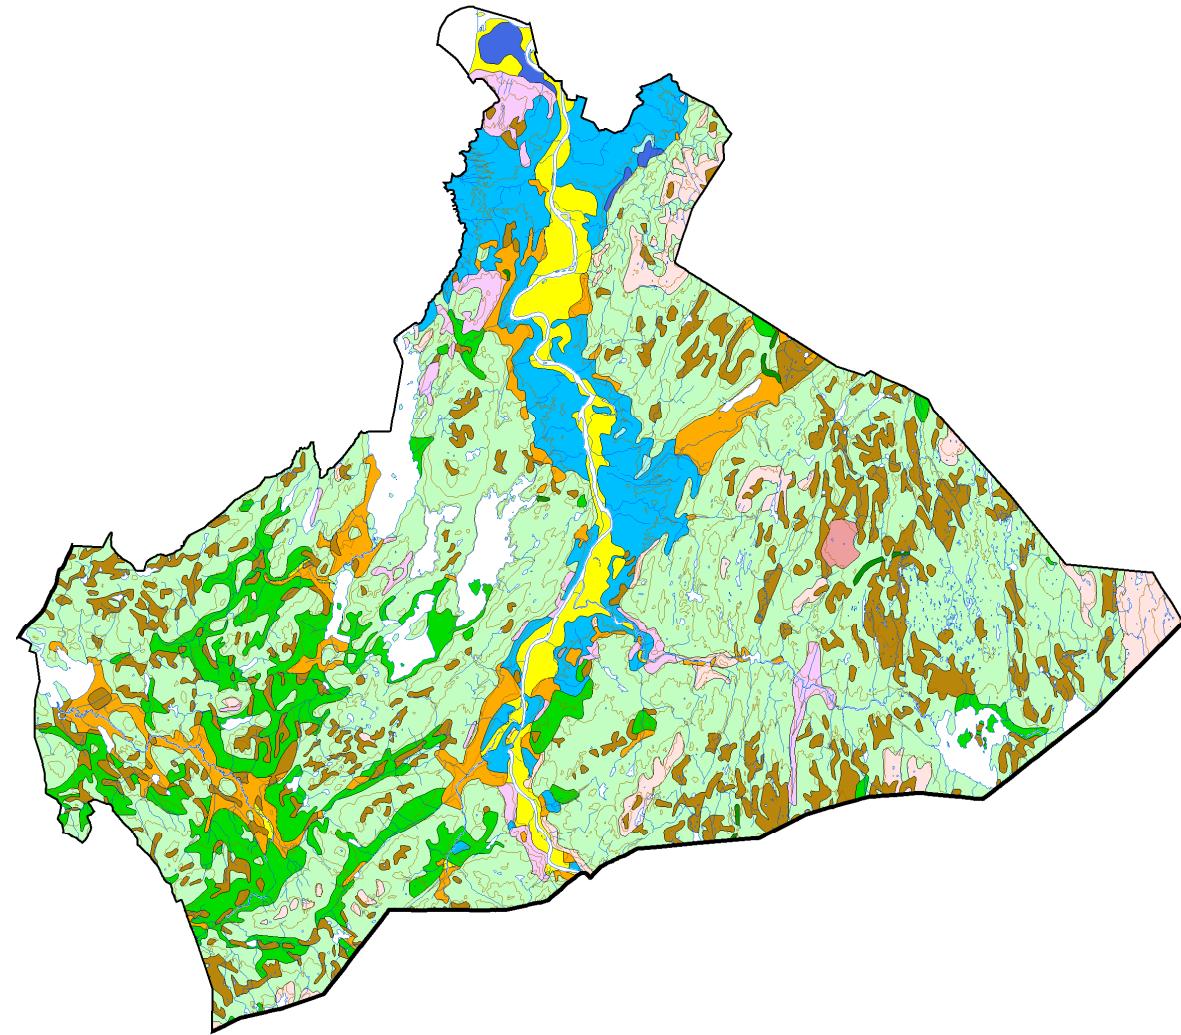
Fluvial

Glaciofluvial

Marine

Till

Bedrock/
mire

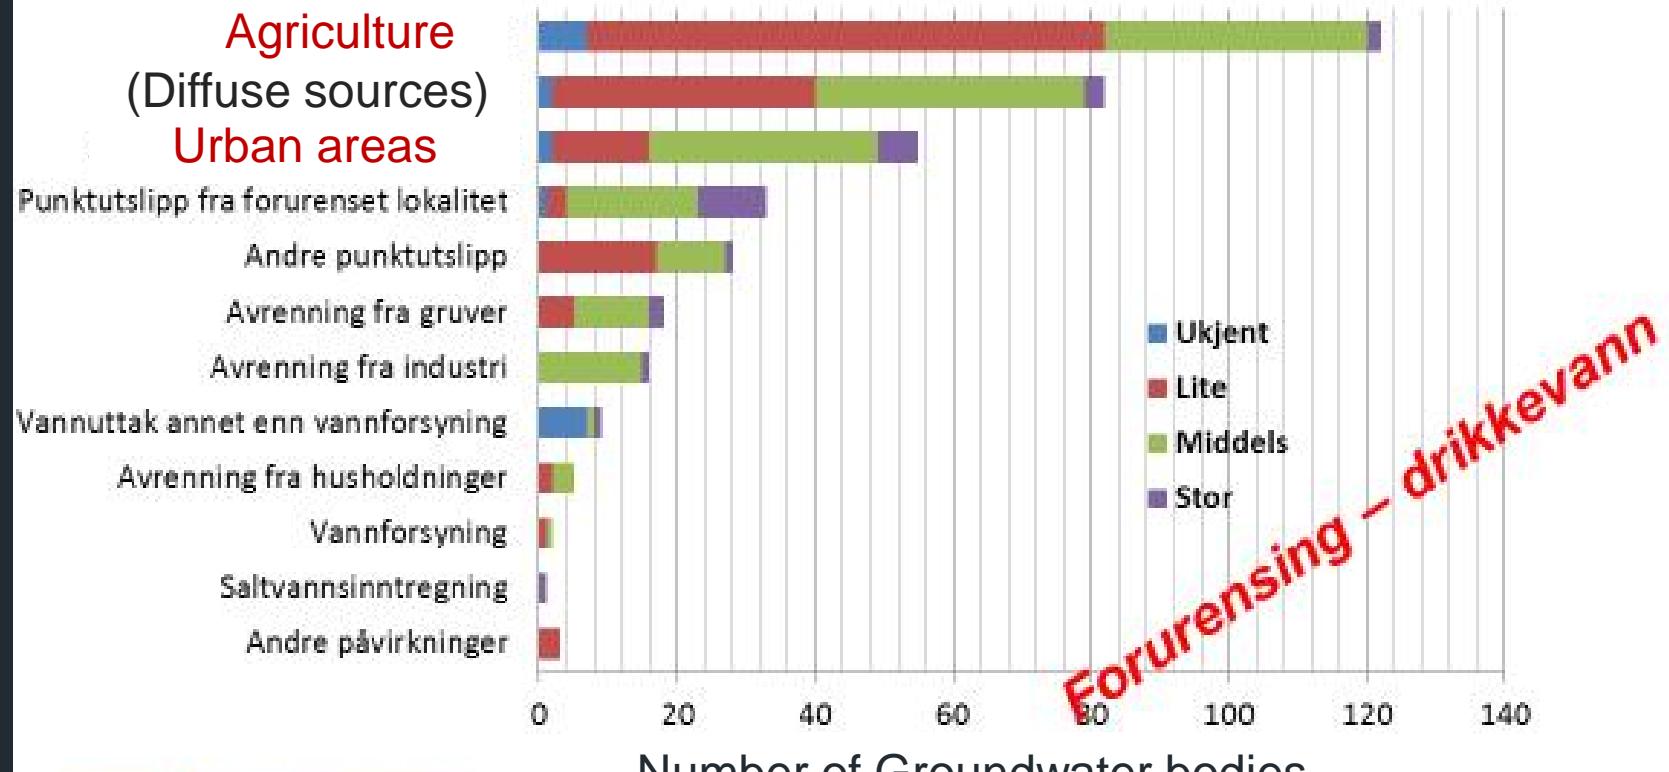
Groundwater bodies influenced by different sources (2010)

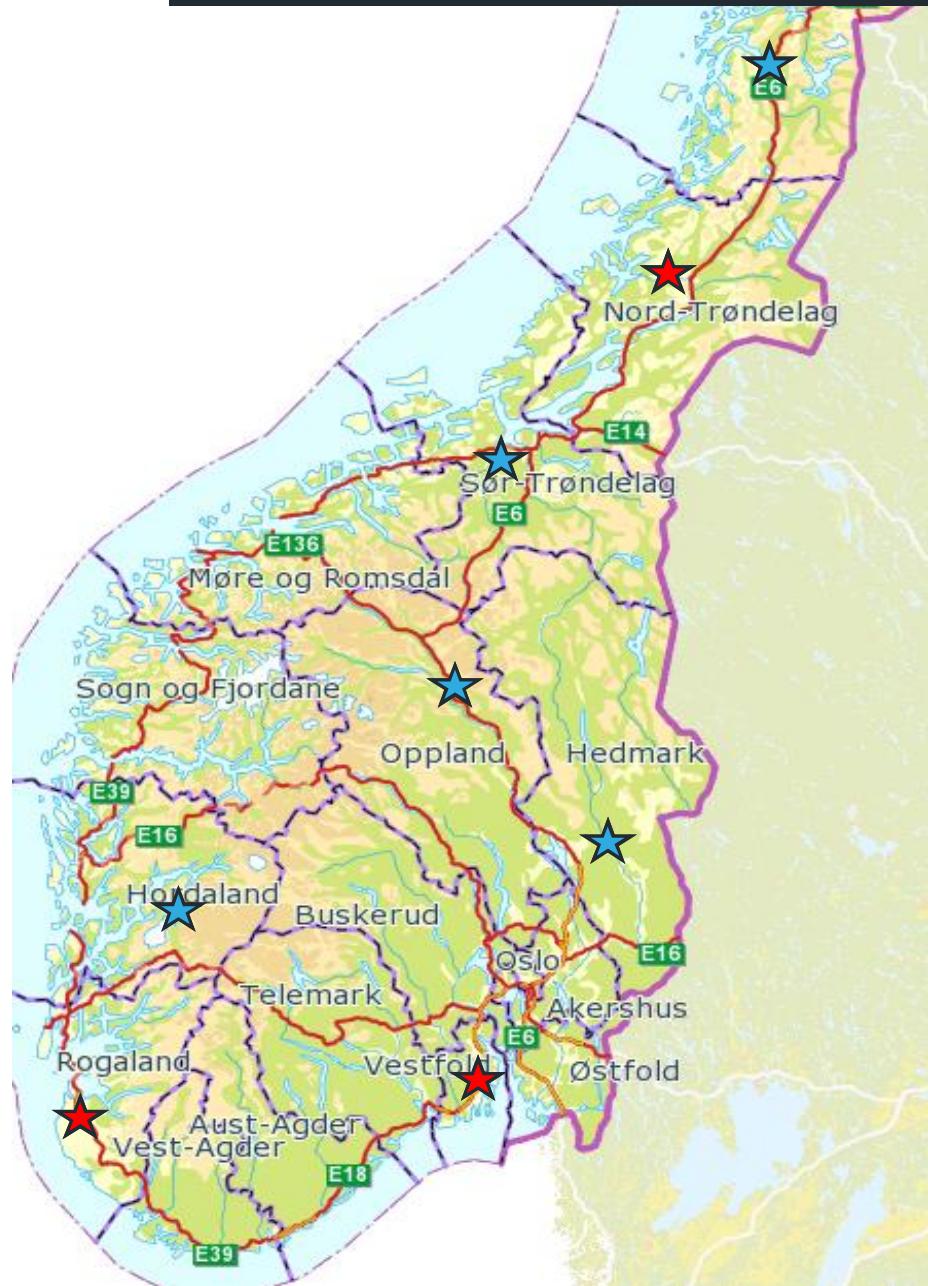
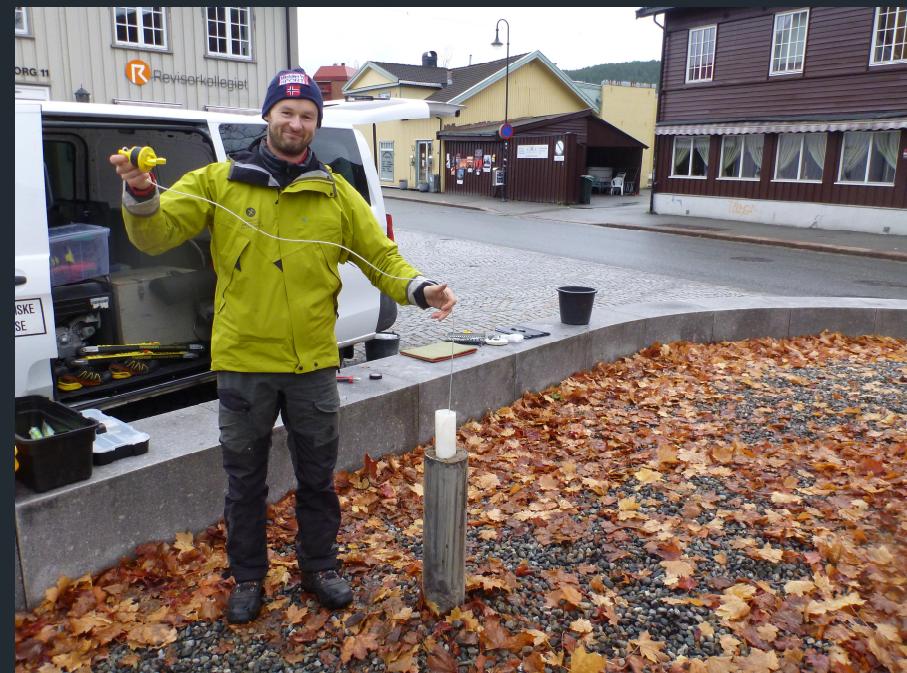
Groundwater sites under anthropogenic pressure

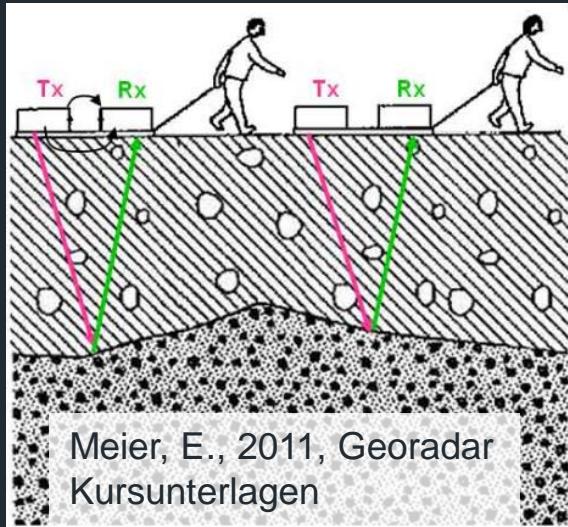
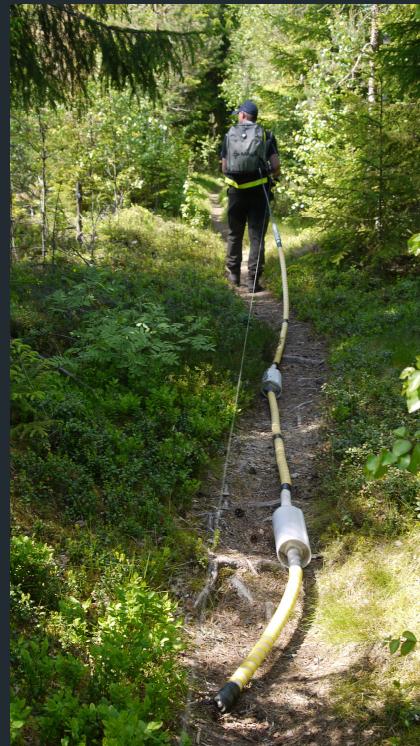
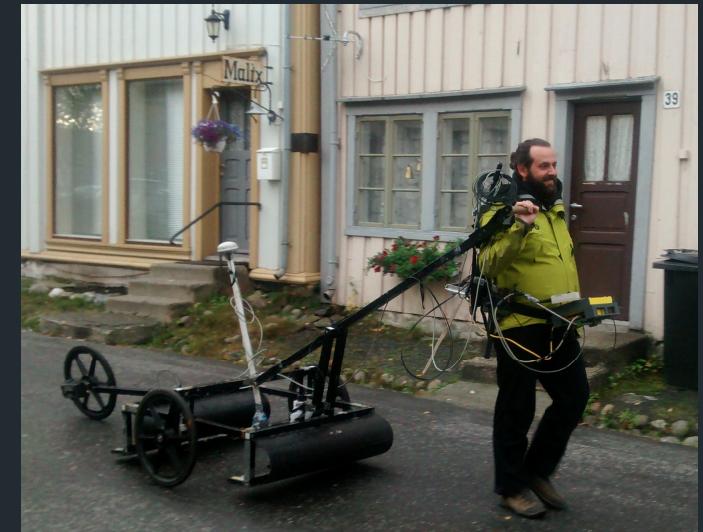
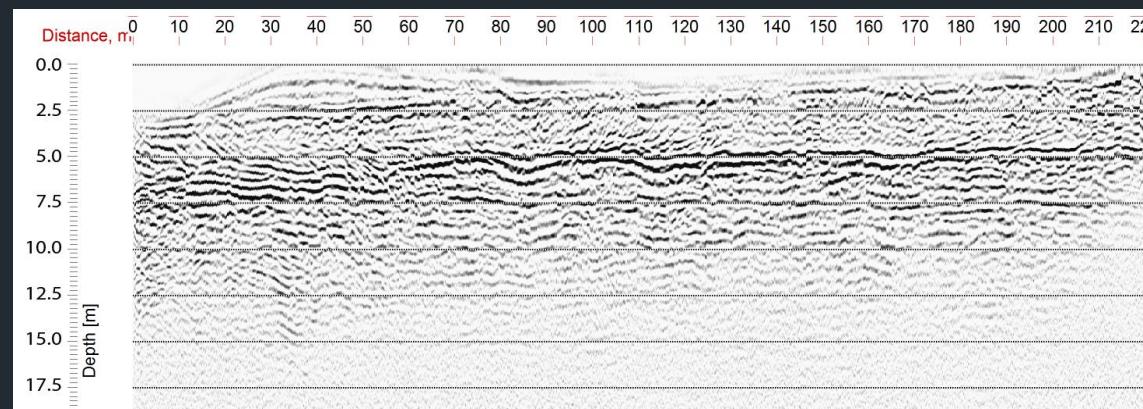
Mapping groundwater - geophysics

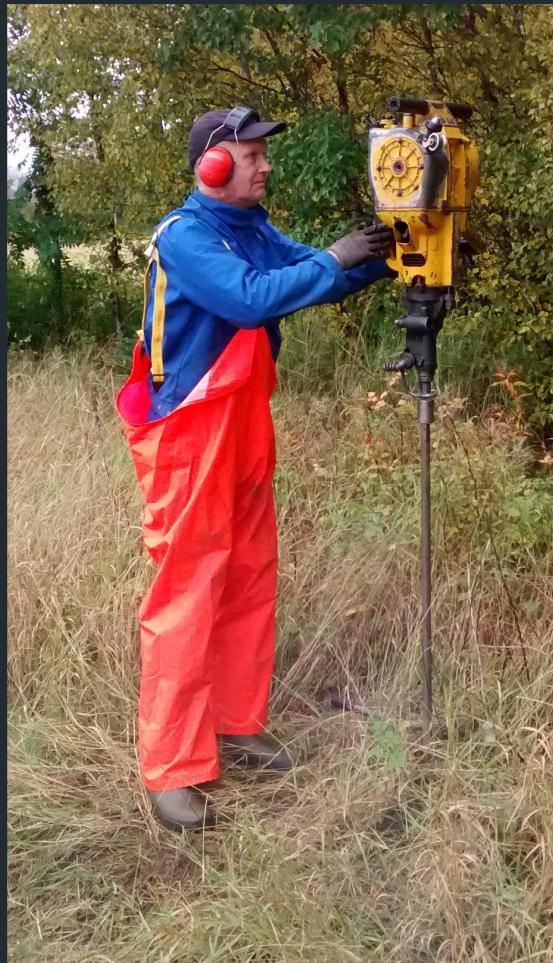
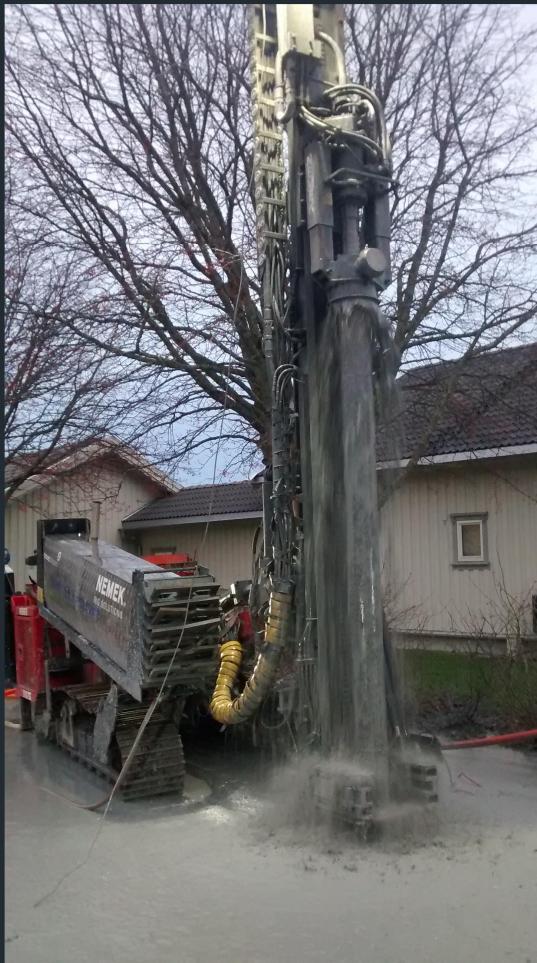
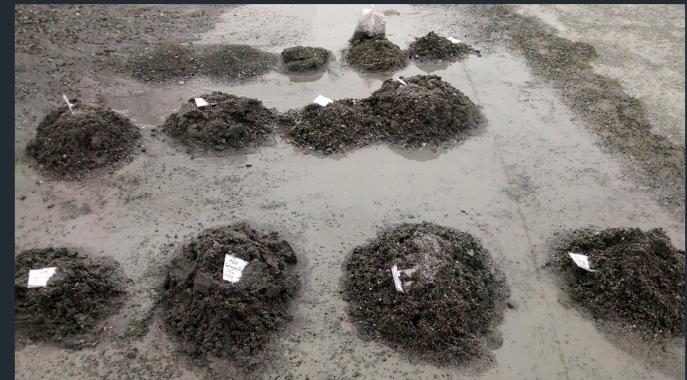
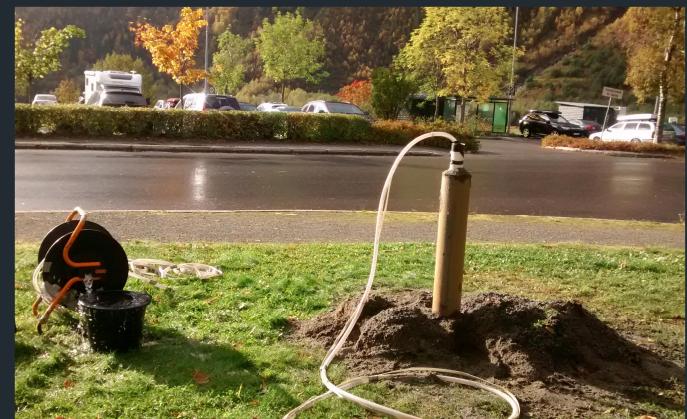
Mapping groundwater - drilling

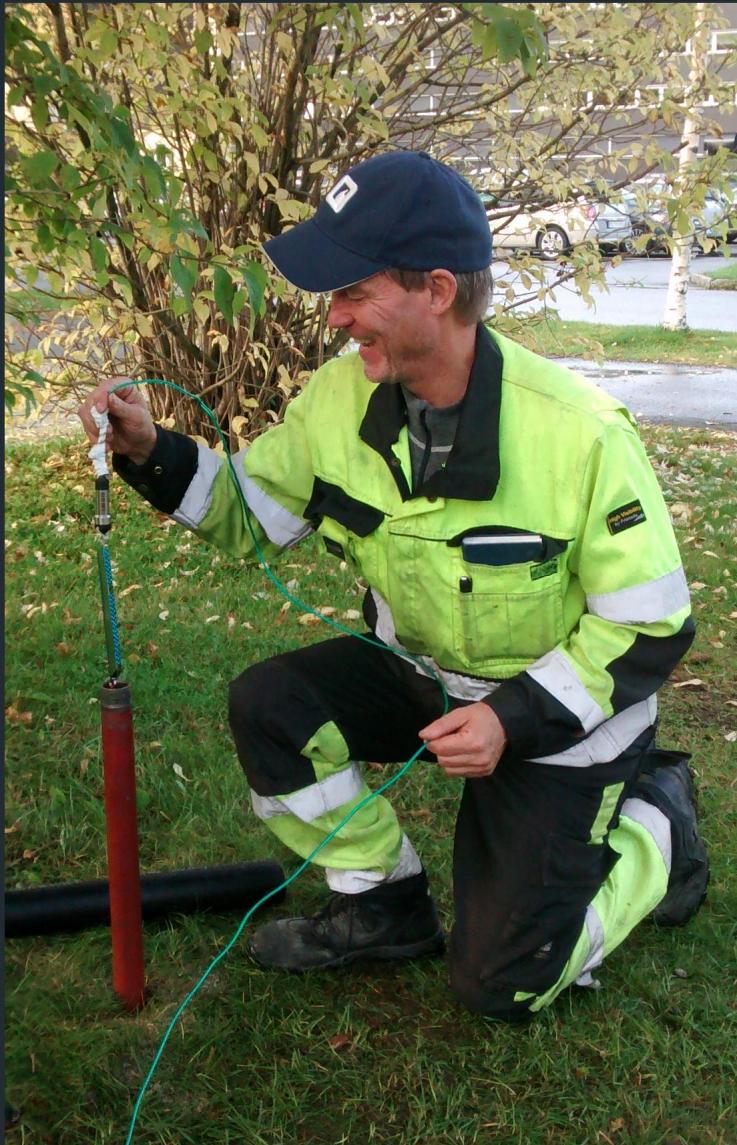
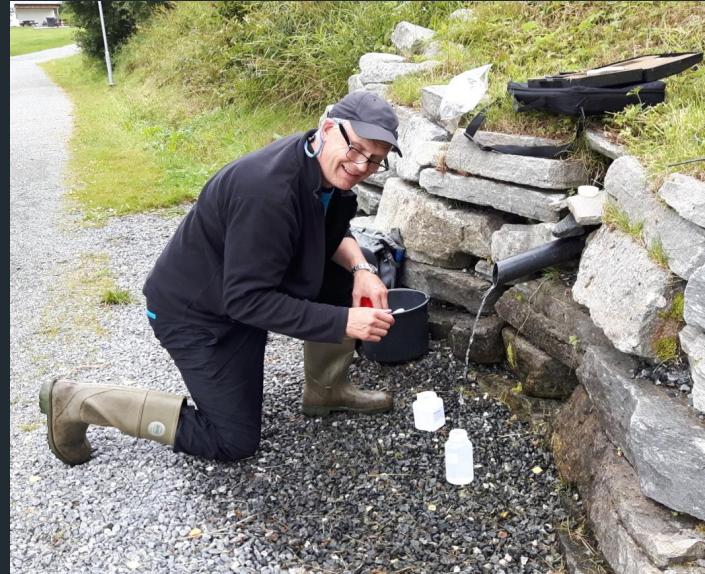
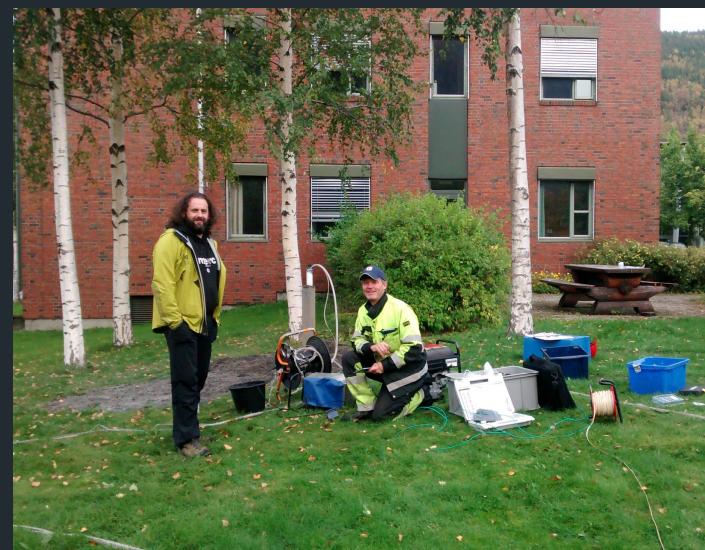
Mapping groundwater - sampling

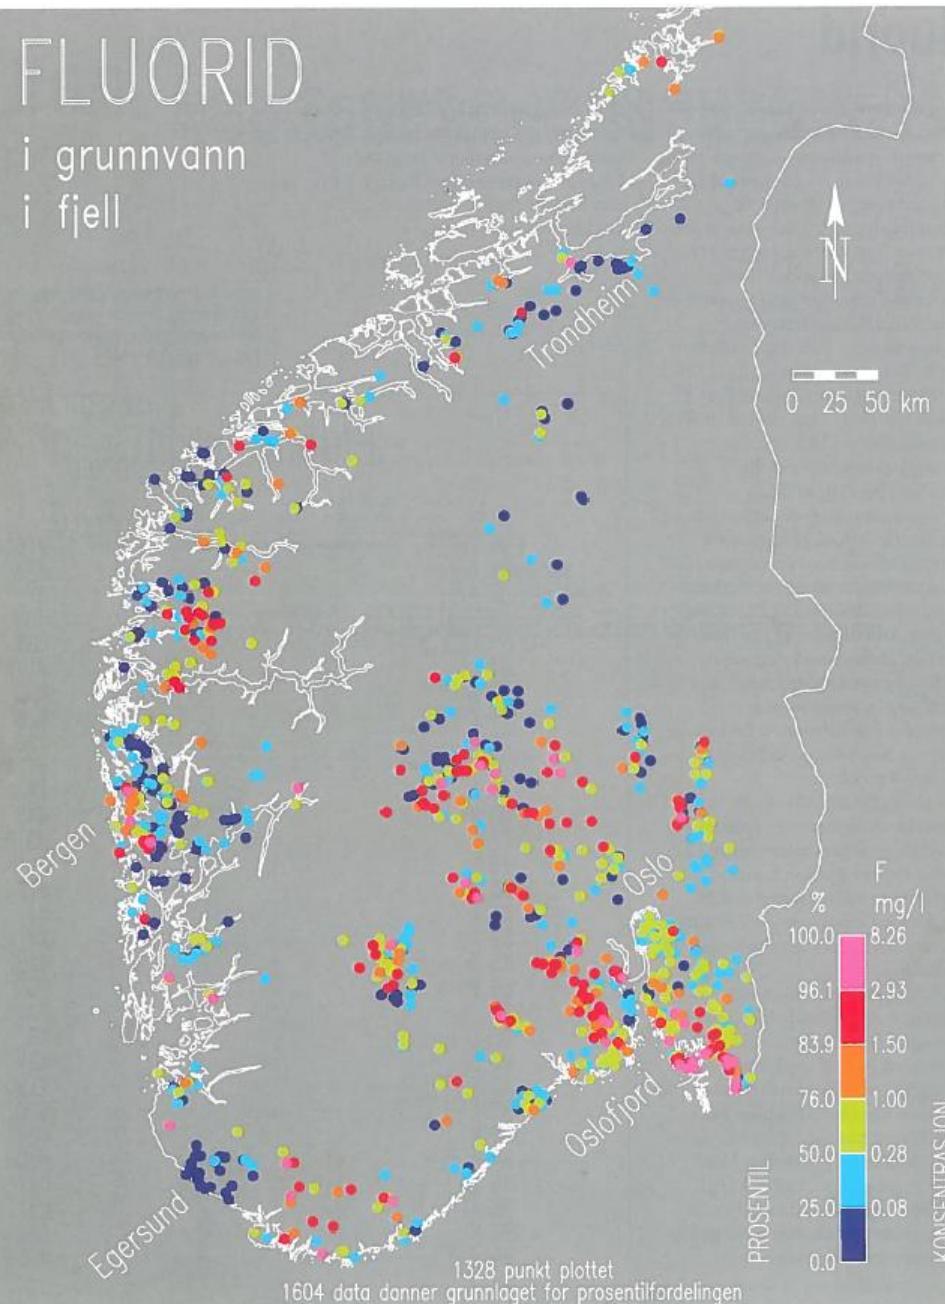
FLUORID

i grunnvann
i fjell

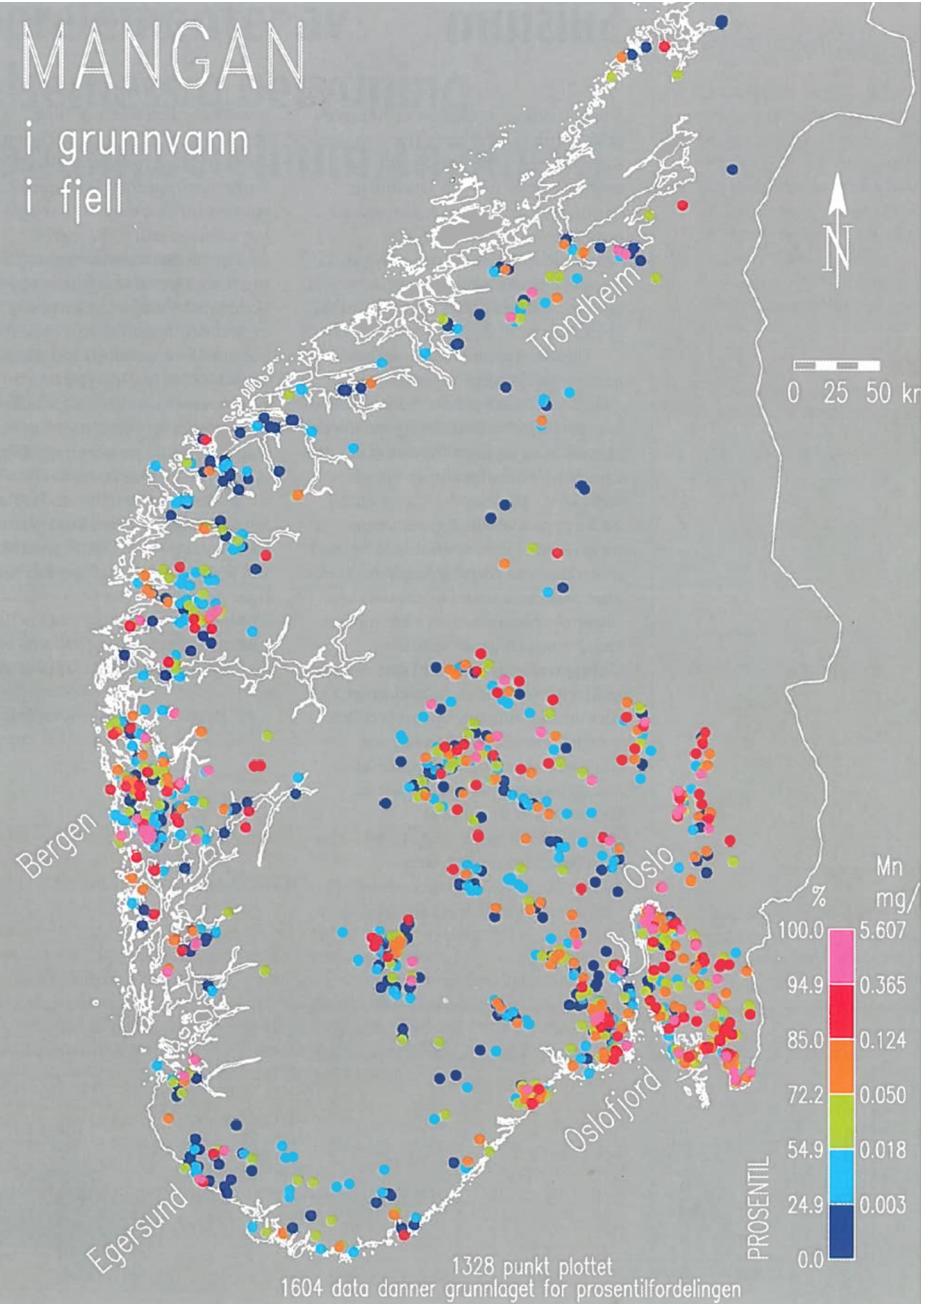
MANGAN

i grunnvann
i fjell

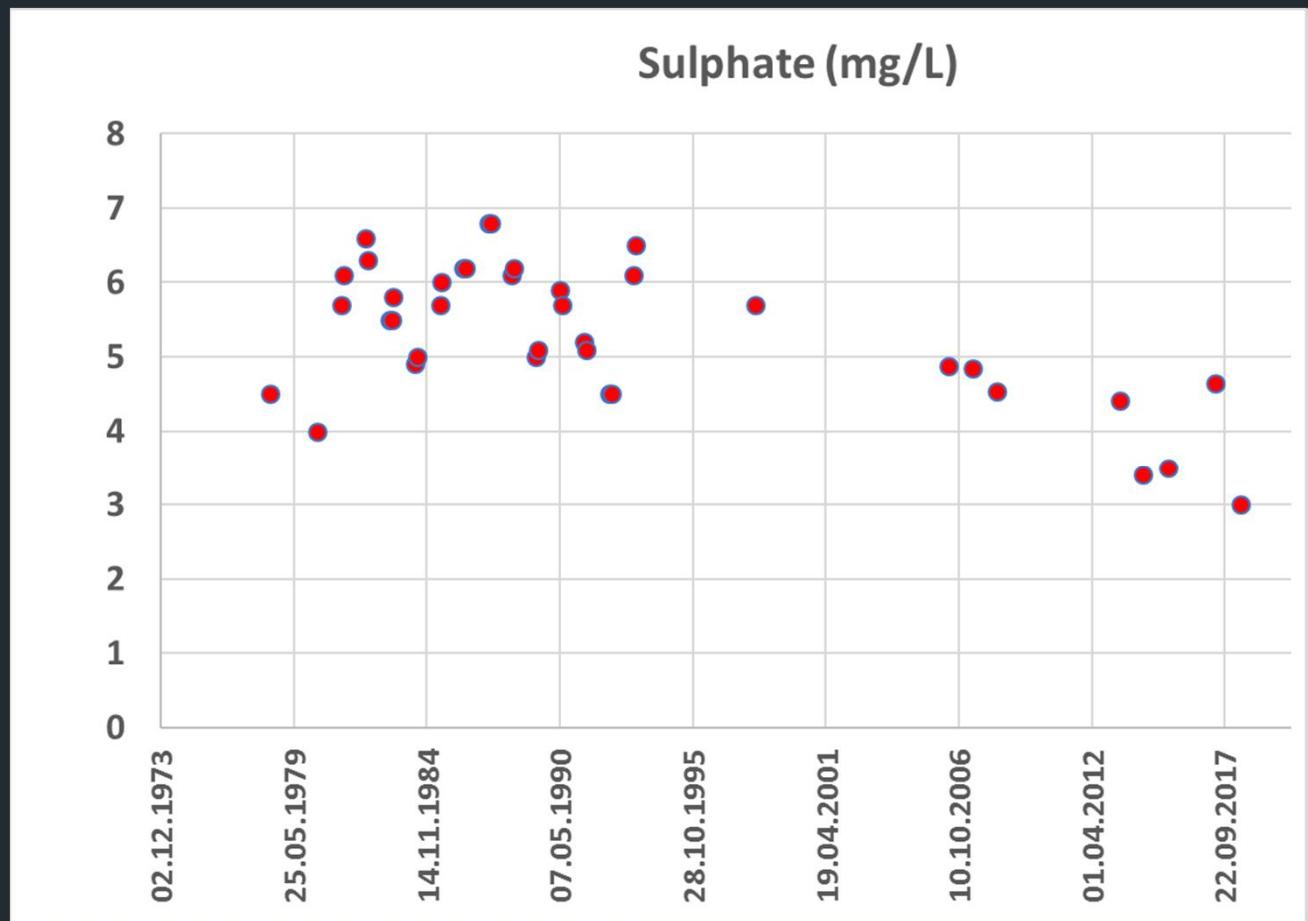
Sulphate at Birkenes

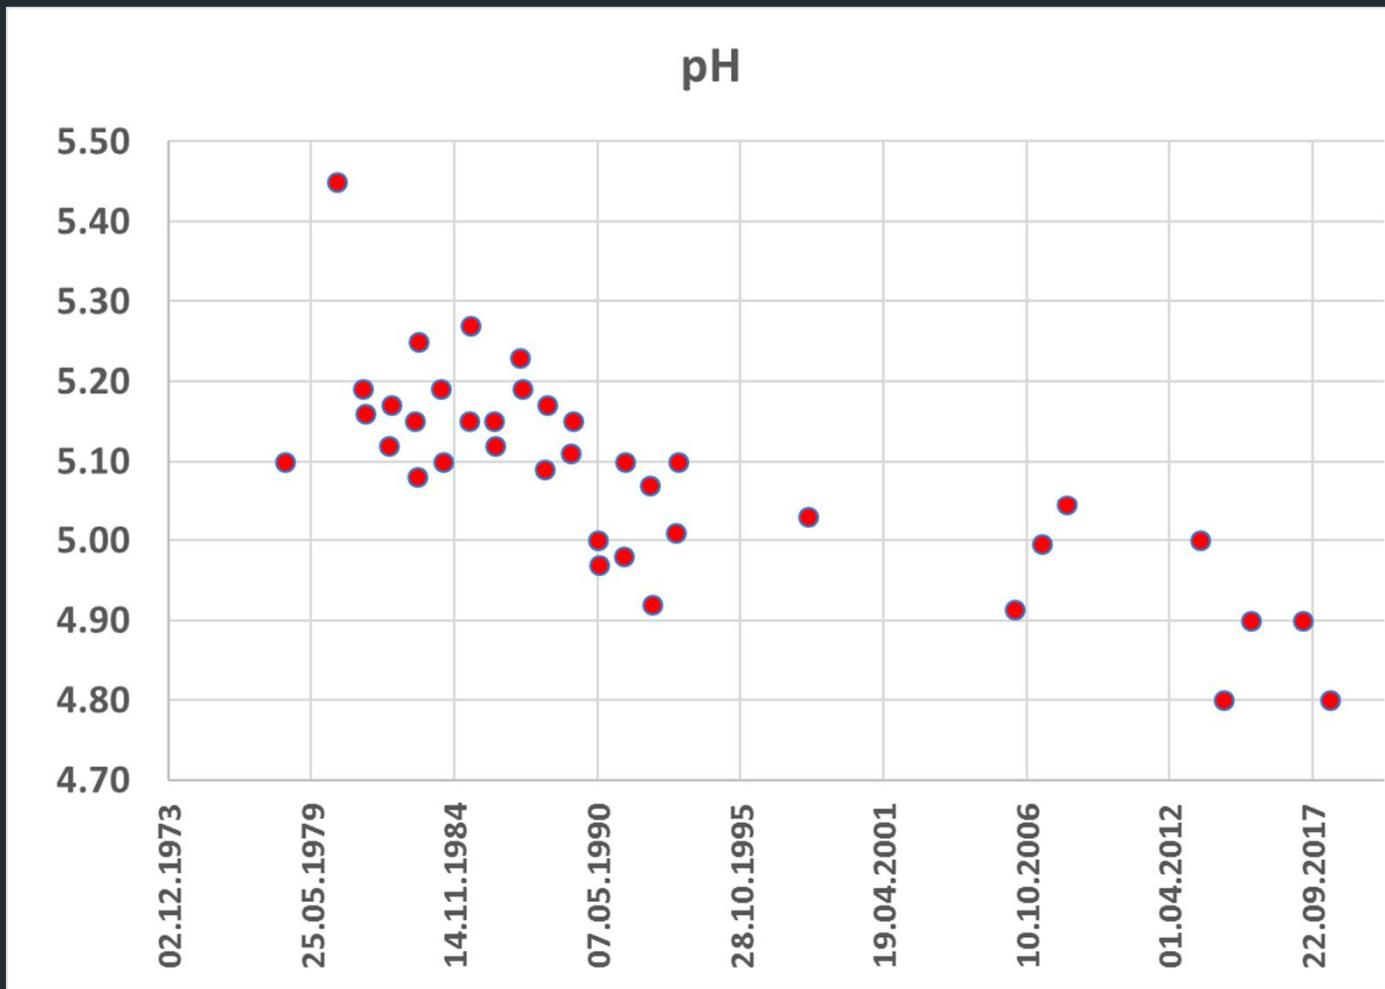
pH at Birkenes (South Norway)

**Southern region; long range atmospheric pollution
=> buffer exhaustion => pH decrease in ground water**

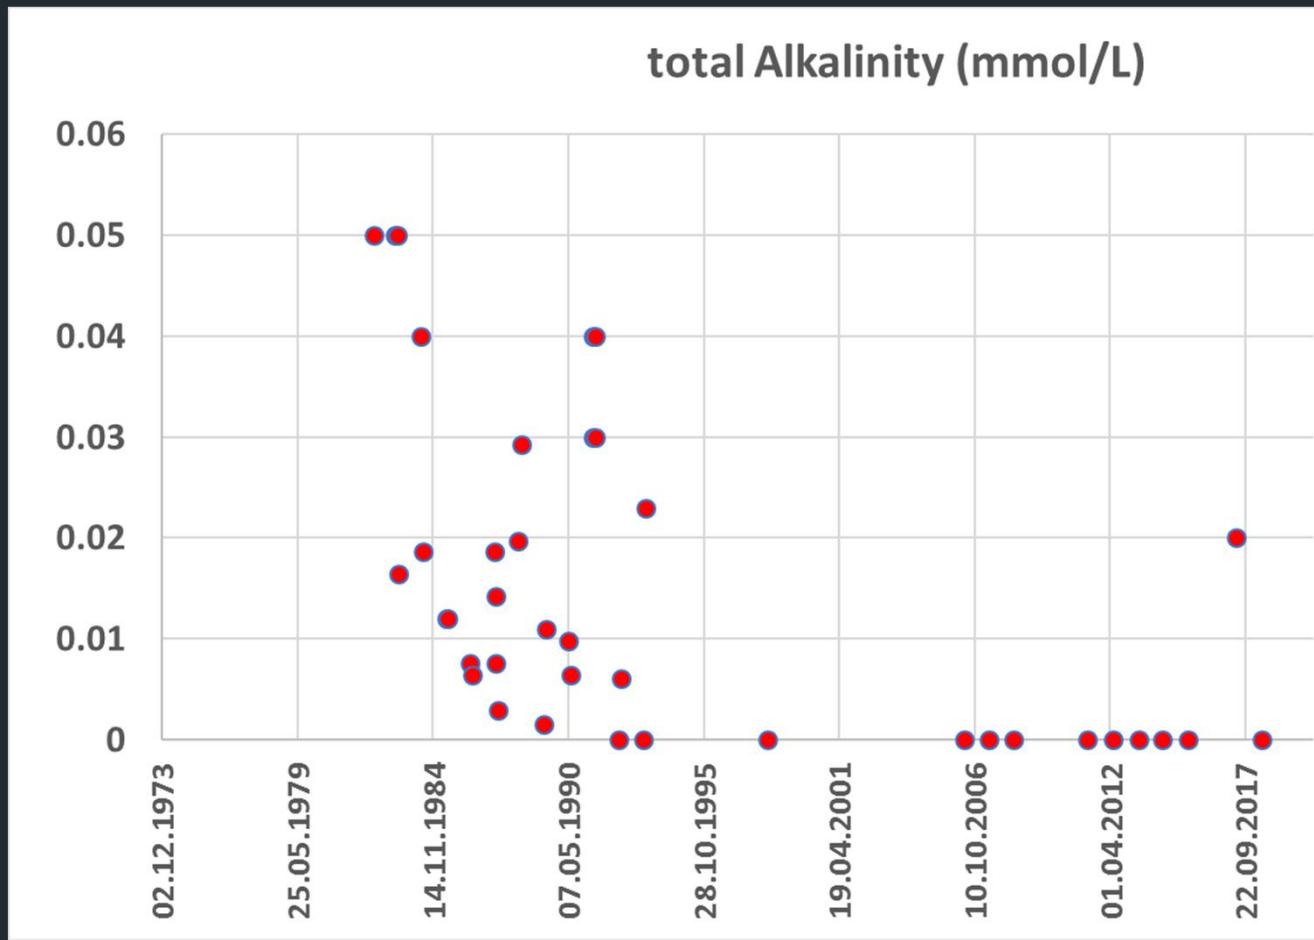
Alkalinity (mmol/L) at Birkenes

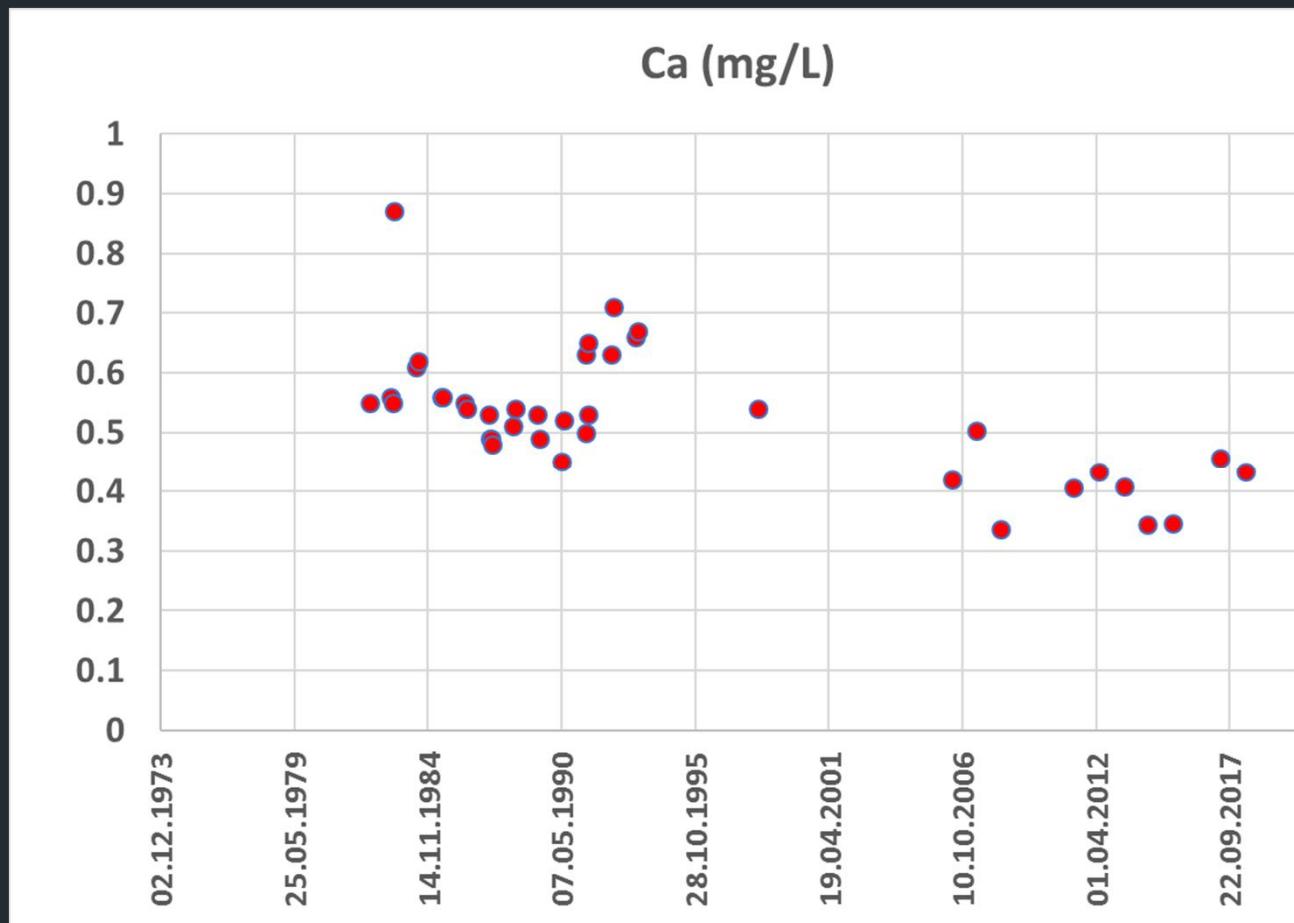
Ca at Birkenes

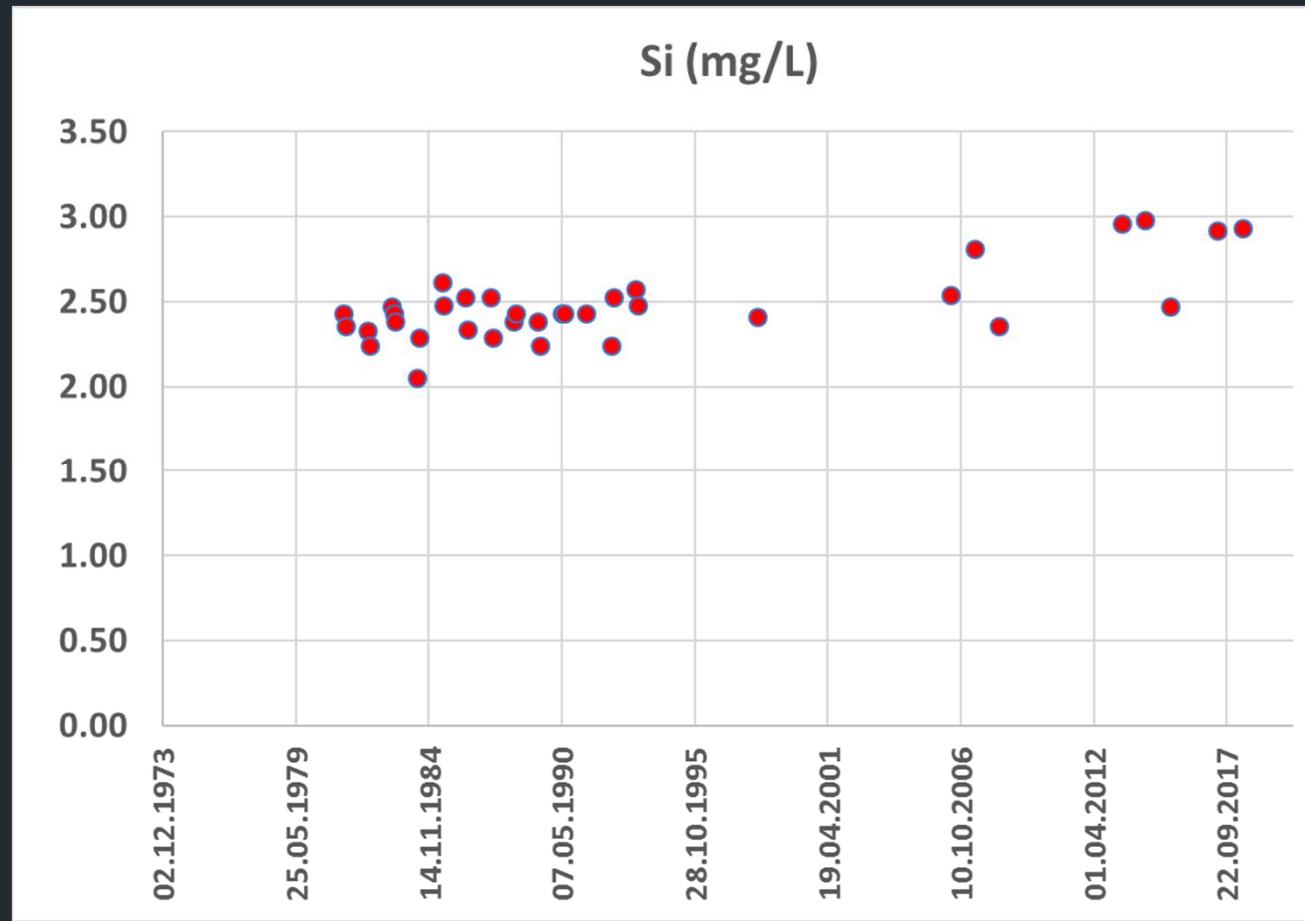
Si at Birkenes

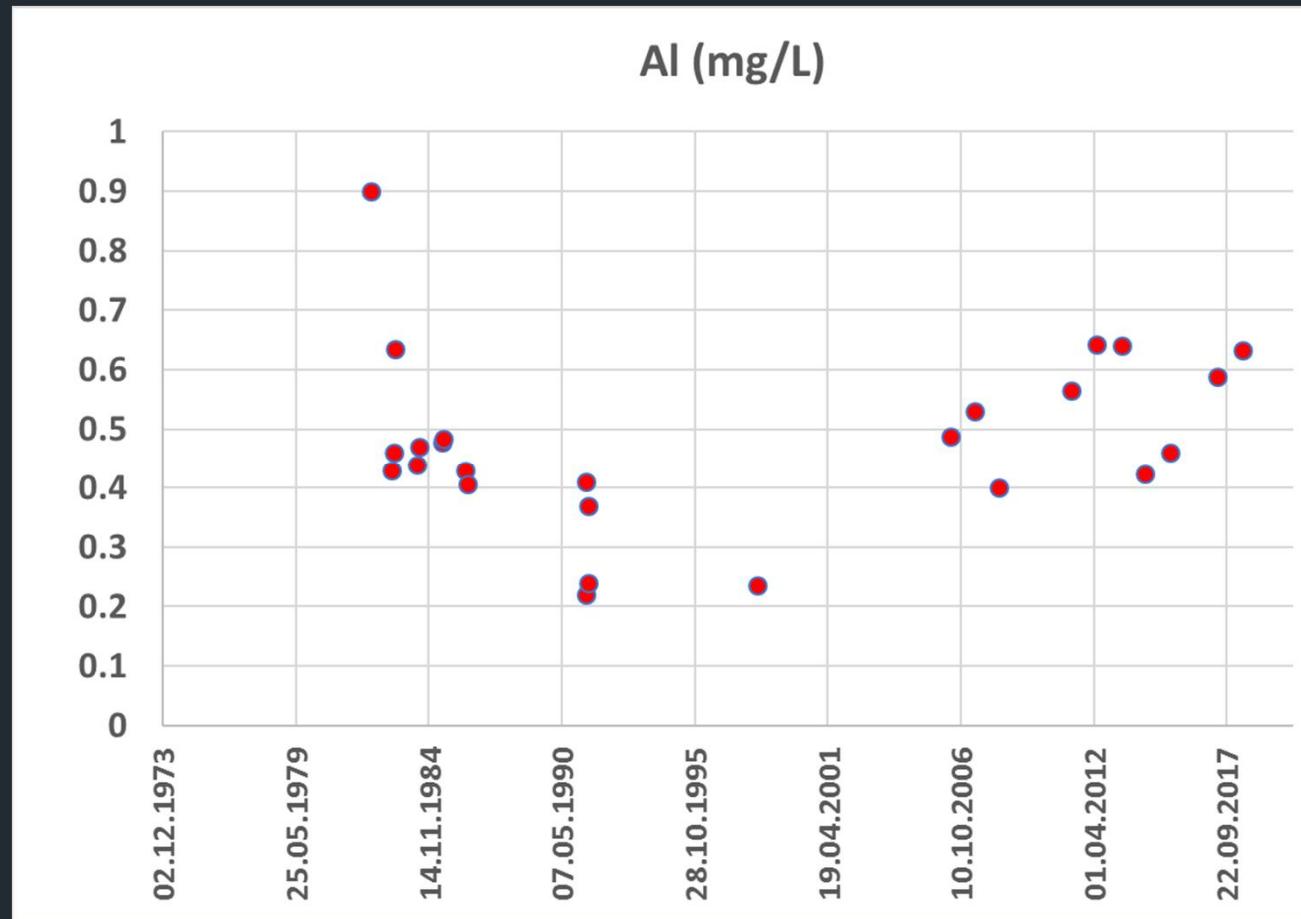
Al at Birkenes

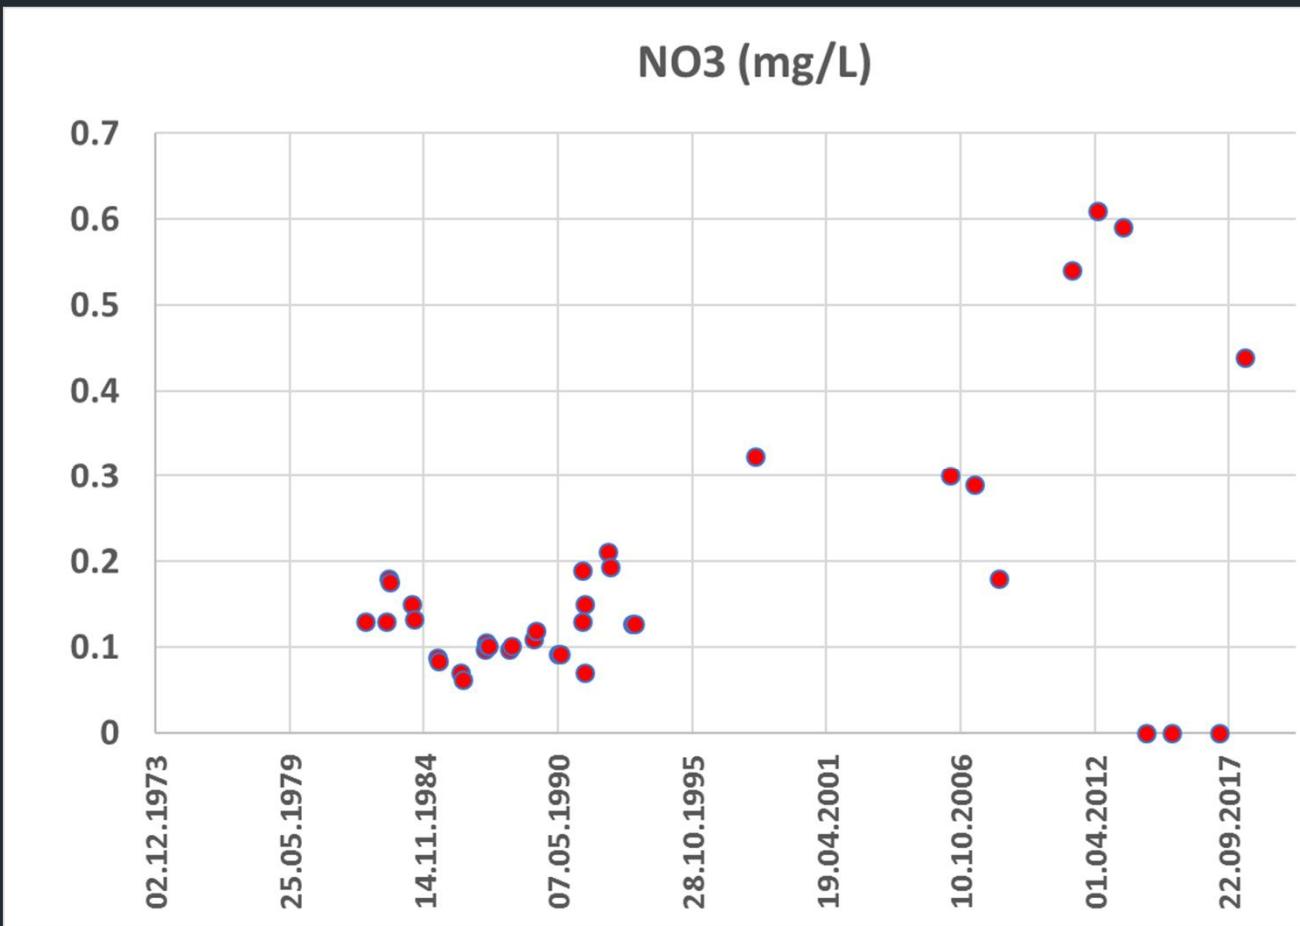
Nitrate at Birkenes

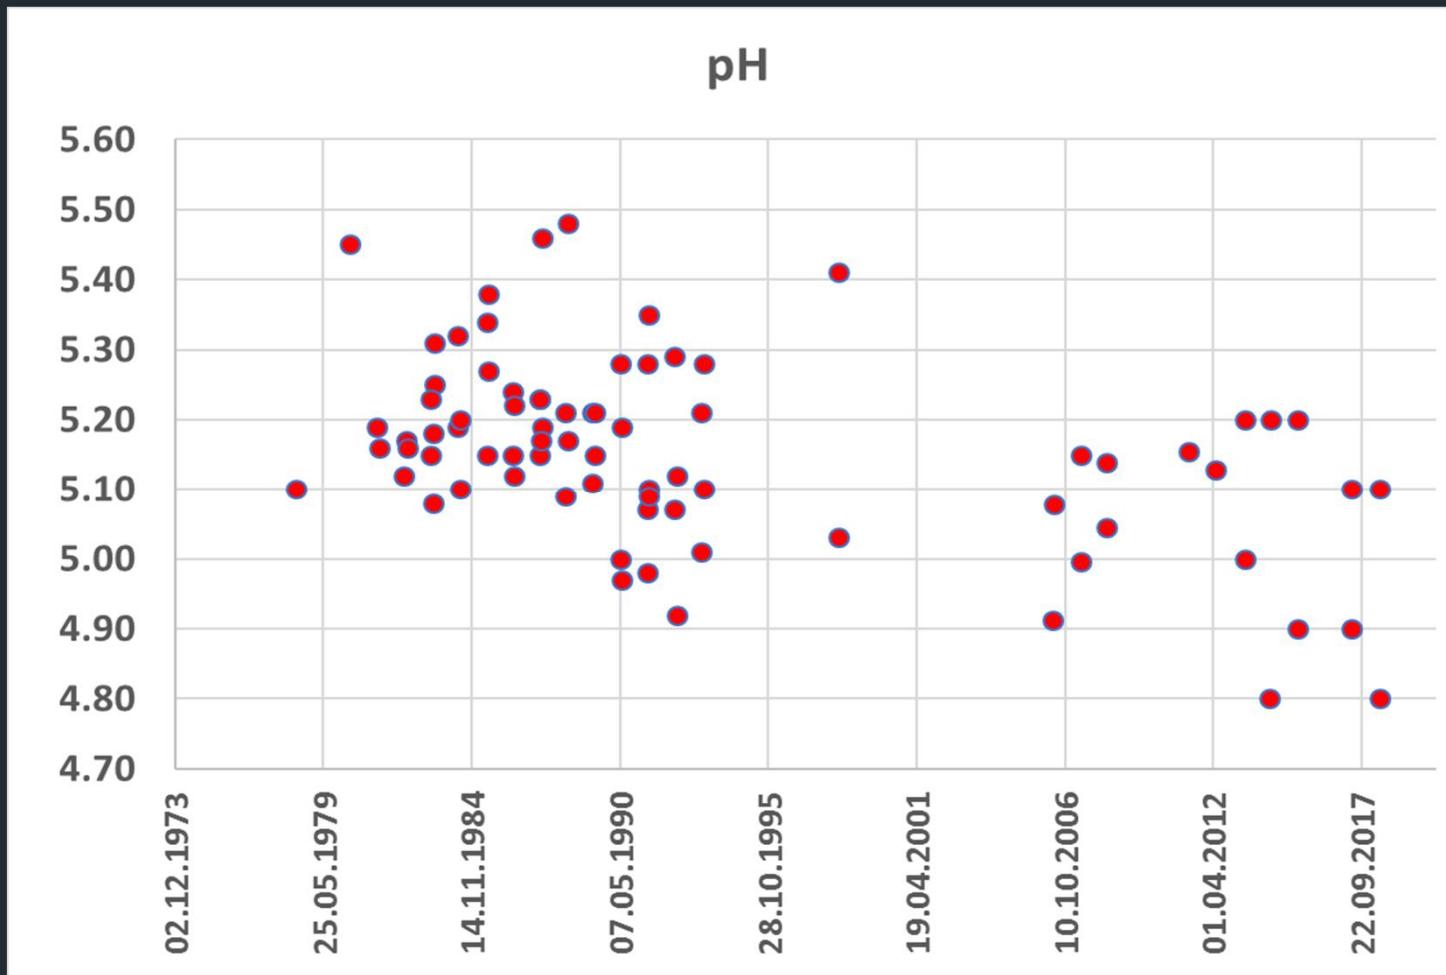
pH at Evje (South Norway)
